AJR 2002; 178:1092-1094

Case Report

Spontaneous Discharge of a Firearm in an MR Imaging Environment

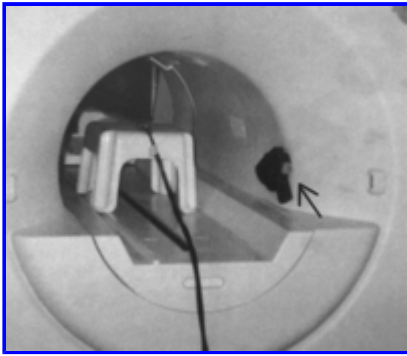
Once the officer was inside the MR suite, the gun was pulled from his hand as he attempted to place the gun on top of a cabinet 3 ft (0.9 m) away from the magnet bore. The gun was immediately pulled into the bore, where it struck the left side and spontaneously discharged a round into the wall of the room at the rear of the magnet. Fortunately, no one was injured. Although the gun struck the magnet bore, only minimal cosmetic damage occurred to the magnet itself. The MR unit had full functional capability immediately after the gun discharged. The weapon's thumb safety was reportedly engaged when the gun discharged.

An unsuccessful attempt to remove the gun from the magnet resulted in the gun being pulled to the right side of the magnet ([Fig. 1](#)). The decision was then made to power down the magnet to remove the gun.

Fig. 1. —Photograph shows gun (*arrow*) stuck on right side of MR imaging magnet bore.

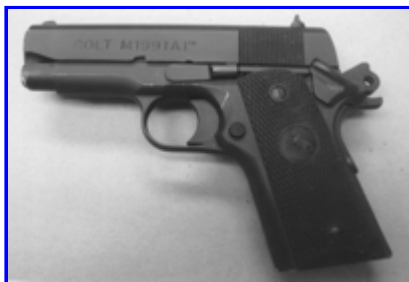
The Colt 1991 A-1 pistol has three safety mechanisms (Fig. [2A,2B,2C,2D](#)), including a thumb safety, grip safety, and firing pin block. The thumb safety locks the sear in place and prevents the hammer from moving forward when the trigger is pulled. The thumb safety also locks the slide in place. The thumb safety is the weapon's only active safety mechanism; it must be turned on in order to work. The grip safety is located at the back of the gun handle and prevents the trigger from being depressed. The grip safety is a passive mechanism; it is always on unless deactivated. To deactivate it, the grip safety must be depressed at the same time the trigger is depressed; otherwise, the trigger cannot be pulled. The firing pin block is a small metal block, approximately the size of a pencil eraser, that sits in the firing pin channel and prevents the firing pin from moving forward. The firing pin block is held in place by a small spring. When the trigger is pulled, a series of levers cam the firing pin block up into its own well within the slide to allow the firing pin to move freely within its channel.

Fig. 2A. —Photographs of 1991 A-1.45 caliber semiautomatic pistol (Colt's Manufacturing, Hartford, CT). Actual gun involved in incident is shown.

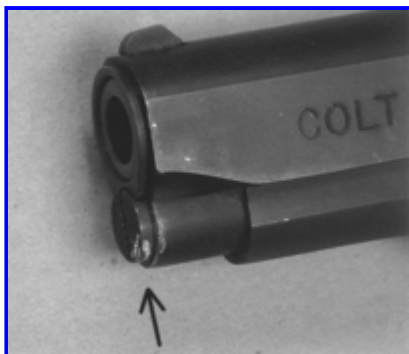
Fig. 2B. —Photographs of 1991 A-1.45 caliber semiautomatic pistol (Colt's Manufacturing, Hartford, CT). Muzzle of gun shows small amount of white paint (*arrow*) where gun impacted magnet.

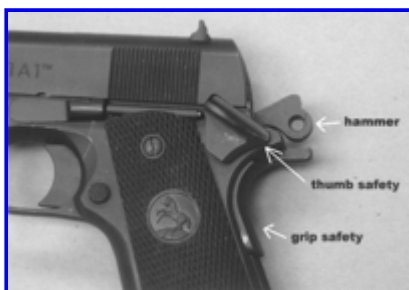
Fig. 2C. —Photographs of 1991 A-1.45 caliber semiautomatic pistol (Colt's Manufacturing, Hartford, CT). Hammer, thumb safety, and grip safety of gun are shown. Gun is in cocked and locked position with hammer cocked and thumb safety turned on to prevent hammer from striking firing pin. This is condition in which gun was recovered from magnet.

At the time the weapon discharged, it was reportedly in a cocked and locked position; that is, the hammer was cocked and the thumb safety was engaged to prevent the hammer from striking the firing pin. A live round was in the chamber. (Many people who choose this weapon for personal protection will carry it in this manner because it allows them to quickly fire the weapon if needed.)

When the firearm was removed from the magnet, the gun was still in a cocked and locked position. An empty cartridge was found in the chamber. The presence of an empty cartridge in the chamber is highly unusual. If the thumb safety were not engaged and the weapon fired normally by depressing the trigger, the normal backward recoil of the slide should have automatically ejected the empty cartridge, and a new live round should have automatically been chambered. As discussed earlier, the thumb safety performs two functions: it prevents the sear from releasing the hammer, thereby preventing the hammer from striking the firing pin; it also locks the slide in place, preventing retrograde motion of the slide and automatic ejection of the empty cartridge. Thus, the presence of an empty cartridge in the chamber confirms that the thumb safety was engaged at the time the gun was fired. Given that the thumb safety was engaged when the gun discharged, it is also likely that the normal trigger and hammer mechanism of firing the gun was bypassed because the thumb safety would have also prevented release of the hammer.

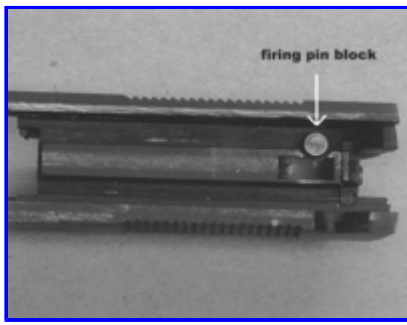
Fig. 2D. —Photographs of 1991 A-1.45 caliber semiautomatic pistol (Colt's Manufacturing, Hartford, CT). Disassembled gun with view of slide interior from below shows firing pin block.

The gun likely discharged as a result of the effect of the magnetic field on the firing pin block. The firing pin block was probably drawn into its uppermost position by force of the magnetic field. The firing pin block has to overcome only light pressure from a relatively small spring to release the firing pin. The pistol was likely drawn into the magnetic field so that the muzzle struck the magnet's bore first. With the firing pin allowed to move freely in its channel, the force of the impact on the muzzle end was sufficient to cause the firing pin to overcome its spring pressure and move forward to strike the primer of the chambered round.
